**Loss of Pitch Control During Takeoff
Air Midwest Flight 5481
Raytheon (Beechcraft) 1900D, N233YV
Charlotte, North Carolina
January 8, 2003**

Aircraft Accident Report
NTSB/AAR-04/01

Loss of Pitch Control During Takeoff

Air Midwest Flight 5481

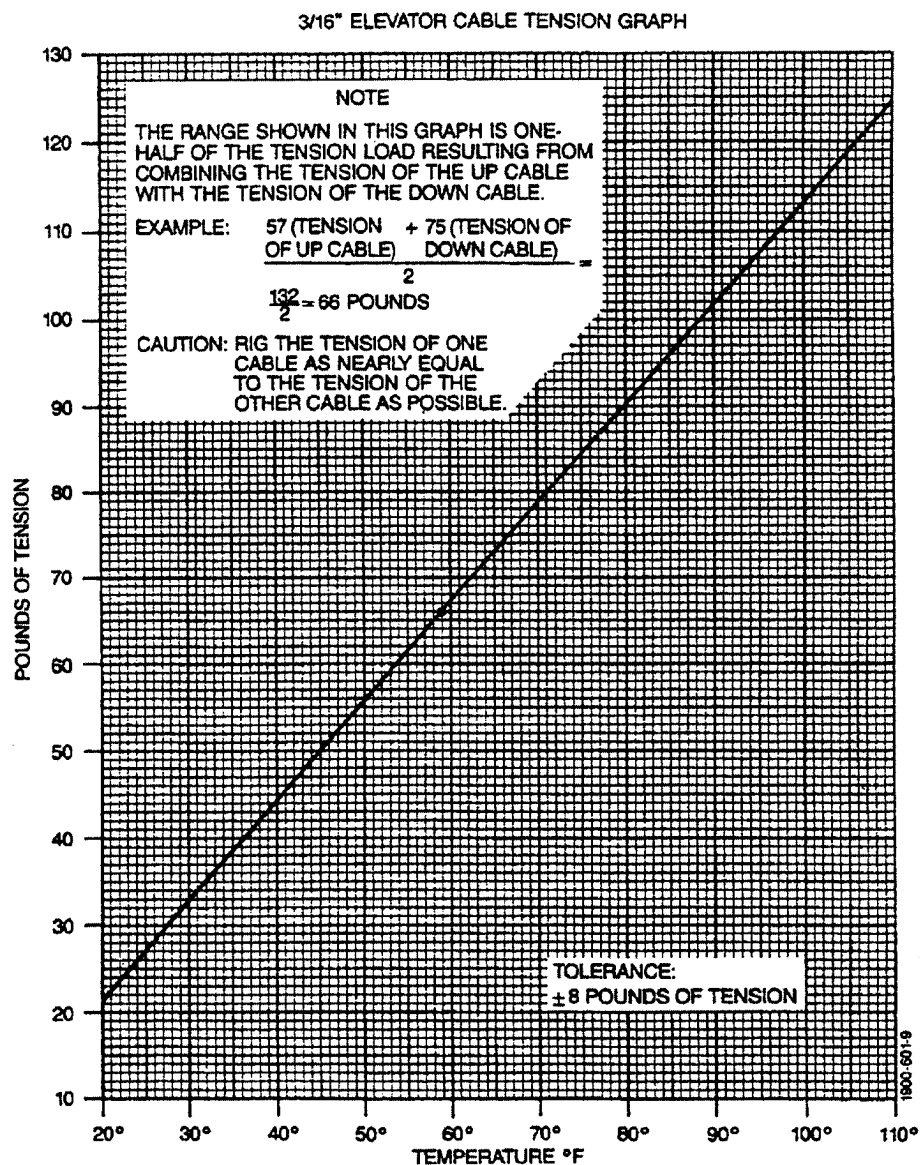
Figure 203 - Elevator Cable Tension Graph

³² Figure 203 was an elevator cable tension graph included in section 27-30-02 of the Beech 1900D AMM. The graph did not contain instructions on how to take a temperature reading.

- Step q refers the mechanic to the elevator cable tension graph (figure 203) in section 27-30-02 for performing cable tensioning, but no instructions were given regarding whether the airframe, outside air, or cable temperature was to be taken when determining the amount of cable tension; whether the flight compartment cabin temperature gauge or an outside air temperature gauge was to be used in determining the temperature; and what type of device was to be used to measure cable tension.

Regarding the Air Midwest accident, the elevator cable tension graph (figure 203) in the elevator control system rigging procedure did not contain instructions on how to take a temperature reading, which was needed to determine the tension values at which the cables should be set. Regarding the Colgan Air accident, the elevator trim system rigging procedure showed an incorrect illustration of the forward elevator trim cable drum. This error could have resulted in the incorrect installation of the elevator trim cable and elevator tab operation in the direction opposite of that commanded by the trim wheel. Regarding the CommutAir incident, the Beech 1900D AMM did not contain a procedure for replacing a thrust lever detent pin.¹⁵²
